D5.3

Report on Tests in Controlled Environment

Contract number:	953432
Project acronym:	FitDrive
Project title:	Monitoring Devices for Overall Fitness of Drivers
Planned delivery date:	M28 (Dec 2023)
Leading partner:	AIPSS
Partners contributed:	ITCL, ROMATRE, UNISAP, SECURETEC, ASELSAN
Document date:	20/12/2023
Version:	2
Subversion:	3
Deliverable type:	Report
Remarks:	This deliverable summarises the activities conducted during the tests of Pilot Cycle 2 in controlled environment.
Status:	<input checked="" type="radio"/> PU (Public) <input type="radio"/> PP Restricted to other programme participants (including the Commission Services) <input type="radio"/> Restricted to a group specified by the consortium (including the Commission Services) (please specify the group) <input type="radio"/> Confidential, only for members of the consortium (including the Commission Services)

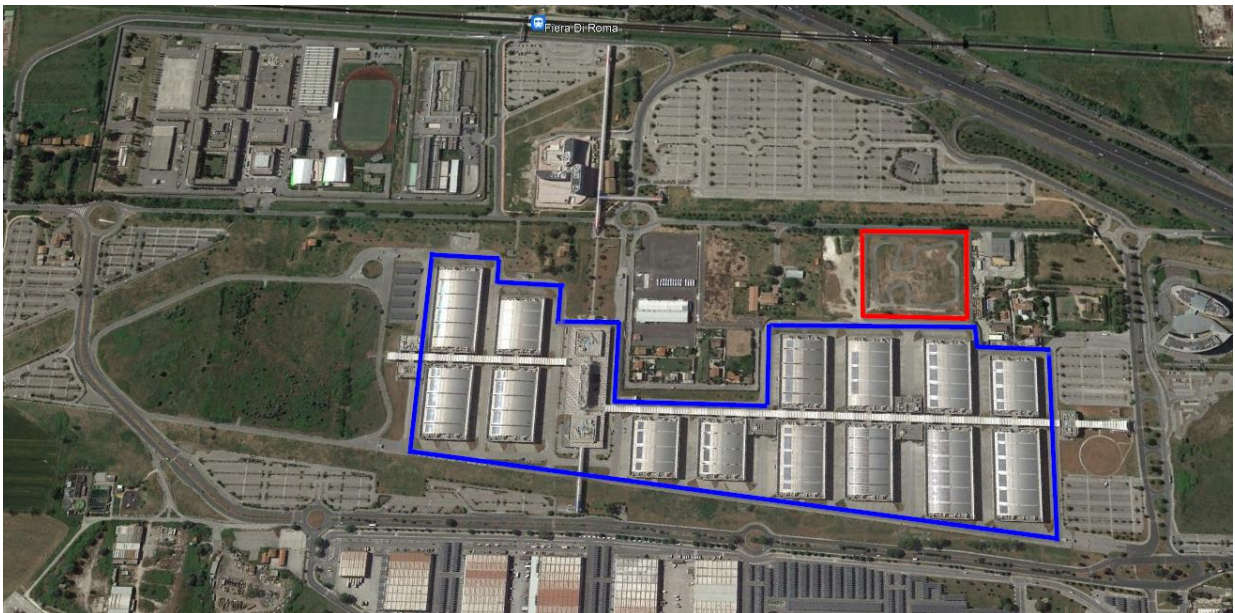
Figure 2: Aerial image of the Fiera with the two available areas marked in blue (Fiera complex) and red (kart circuit).

The blue marked area is the general Fiera complex, and the red-marked area is a small kart circuit adjacent to it. The complexity and narrowness of the circuit has been used for the high demanding task, while the straight and wide roads of the complex are a good choice for the monotonous task.

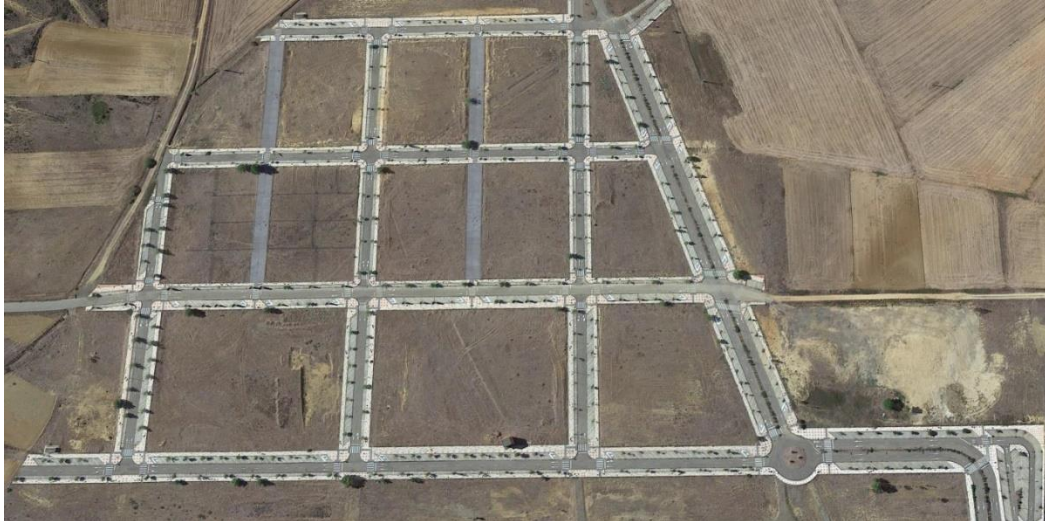
Figure 3: Aerial image of the abandoned urbanization area in Valladolid.

The location chosen for C1 and C2 in Spain is an abandoned urbanization in Villatoldanos, León. Despite being a public road, there is no traffic since there are no buildings and the city council closed off the roads during the experiments, so these were performed in a controlled environment. Being a squared road network, different exercises have been organized for the three planned tasks.

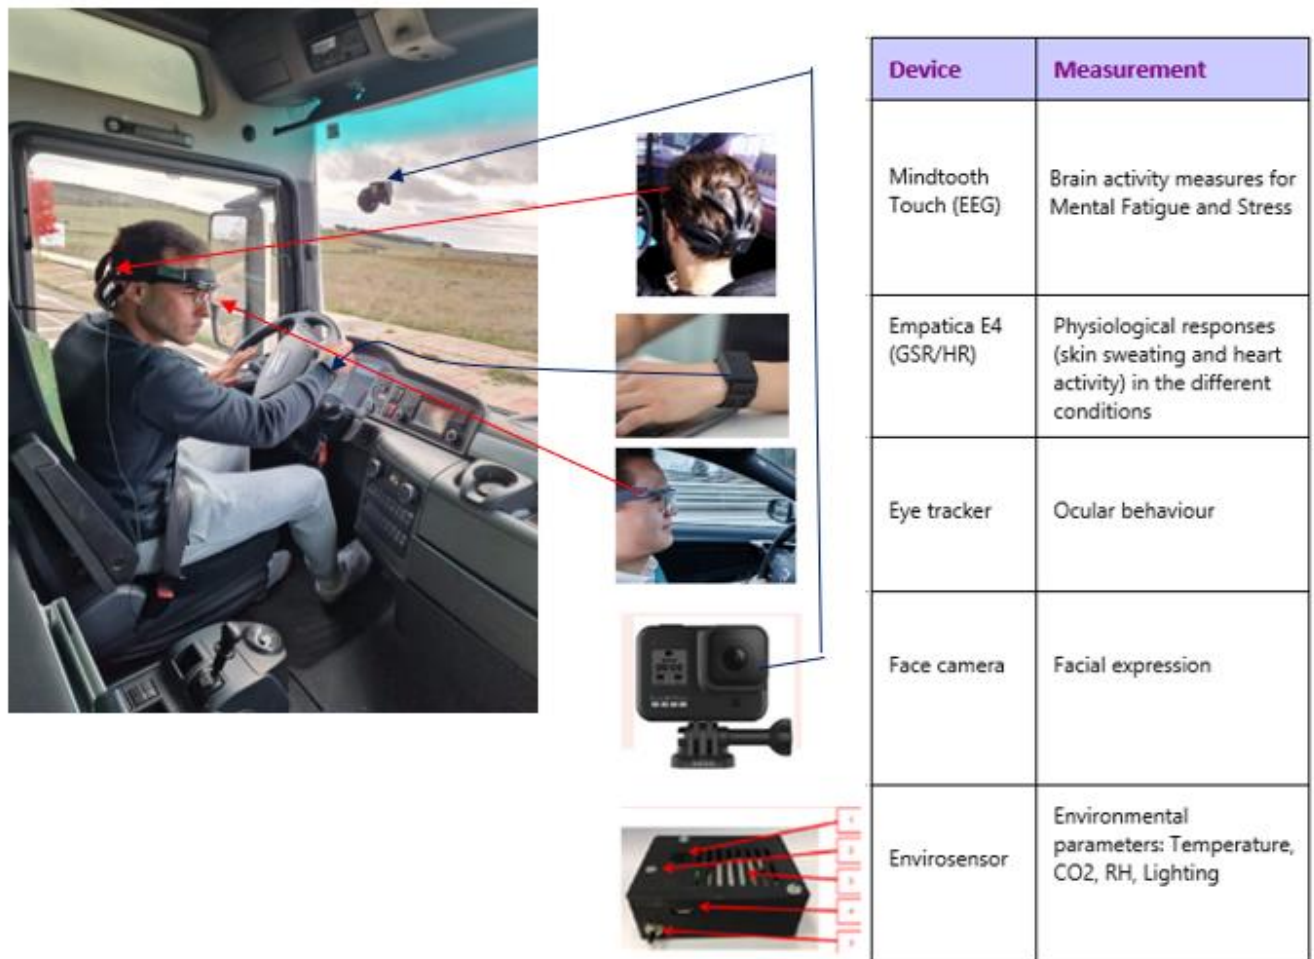
Figure 5: Devices for measuring the driver's neurophysiological data (picture taken during the C2 tests in Spain).

There were two groups of devices: the first one focused on parameters able to define the neurophysiological status of the driver, and the second one focused on vehicle data.

The list of devices and data measured is shown in Figure 5:

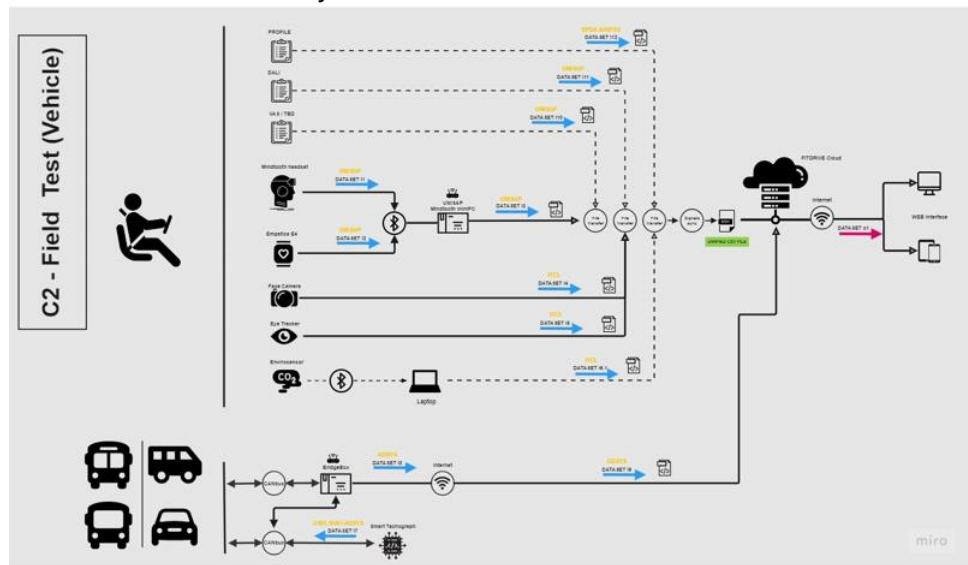
Figure 7: Scheme of the cloud-based data transmission.

Vehicle’s data collected during the tests were transmitted in cloud; such a transmission will become relevant in the future cycle 3 tests, where the drivers are expected to drive for one month “as usual” during their working hours; in general, during the C3 test, they may avoid having contacts with the project staff, but a continuous monitoring is necessary to check the correctness of the data gathered. To this purpose, the partner ADSYS developed a cloud-based system able to check every few seconds the connectivity and correctness of the transmission. In case of simple issue (e.g. battery exhausted) the driver could fix them through instructions given by phone; for more complex situation, the driver will be asked to come back to the garage. In Cycle 2 tests the system has been successfully validated.

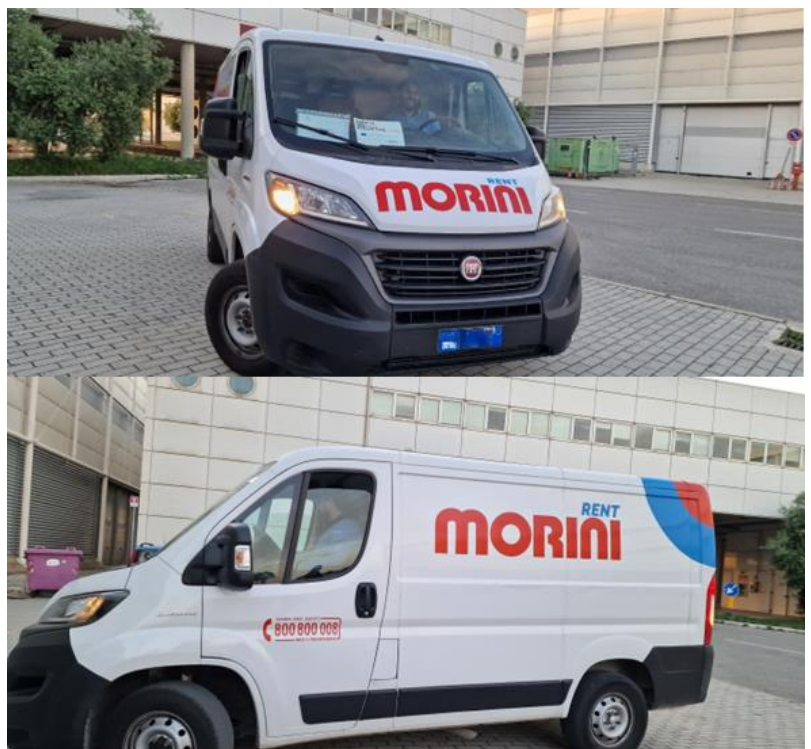
Figure 9: Van used for the C2 tests in Italy.

The van for the test was a Fiat Ducato showed in the picture. There were in average 2 tests per day according to the scheme “High demanding task (Kart circuit) – monotonous tasks (straight and wide roads).

The volunteers were equipped with the wearable EEG headset, i.e. the Mindtooth Touch (<https://mindtooth-eeg.com/>), a wristband, i.e. the Empatica E4 (<https://www.empatica.com/en-eu/research/e4/>), and the eye-tracker glasses, i.e. the Tobii Pro Glasses 2 (<https://www.tobii.com/products/discontinued/tobii-pro-glasses-2>). Further sensors were placed in the van for the measurement of CO₂ concentration in the air; percentage of

relative humidity; air temperature and light intensity. A camera was placed on the internal side of the windscreen.

The van was also equipped with the "Bridgebox" developed for the detection of the driving data and their transmission through the cloud.
